Client Ref. : --
Report No. : 195909PC190345(3)

REPORT ON TESTING OF DUCTILE IRON CONNECTOR

Client : Wah Hung Fire Prevention Equipment Co., Limited
Client Address : G/F, No.75, Bedford Road, Tai Kok Tsui, Kowloon, Hong Kong
Sample Description : Ductile iron tank connector (puddle flange) with three nos. of flanges, pressure rating PN16
Item No. : WH026B
Brand : WAH HUNG
Body Markings :

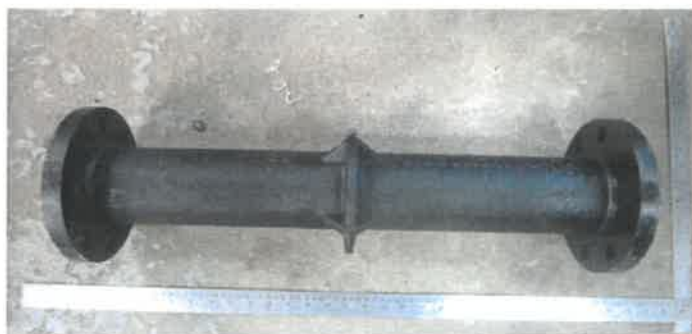
Test Sample
Sample I.D.: PC190345/4

Remark : 1.) An epoxy coating was visible on the visual internal water contact surface of the sample.
2.) The test sample is shown in the photograph on page 4 of this report.

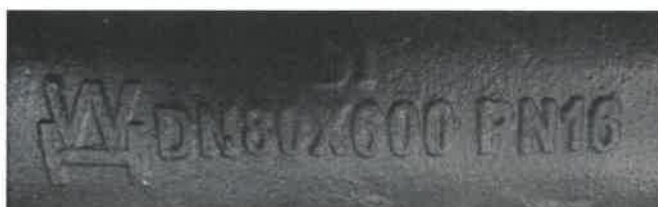
Body Marking
Sample I.D.: PC190345/4

DI DN80X600 PN16 BSEN1092-2
Country of Origin : China
Model : DI-8024
Manufacturer : Wah Nan Fire Fighting Equipment Co., Ltd
